Electronic Theatre Controls, Inc.
3030 Laura Lane
Middleton, WI 53562

Manual 4052M1019 Obsession Upgrade Installation Instructions

Obsession Full Console Upgrade Kit (4052S1018)

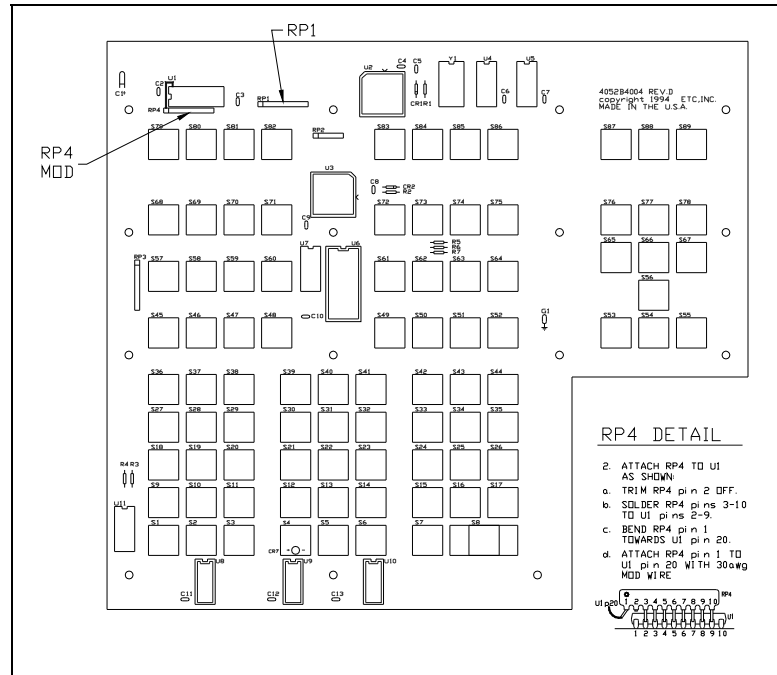
Figure 1

This modification adds resistor pull-ups to the BD data lines and changes another pull-up package to increase the current through the GO and STOP/BACK switches. When the FIFO empty flag is read through the local port, only bit zero is active and the rest of the bits float. This injects noise into the active bit and can cause it to be misread. The resistor pull-up for the GO and STOP/BACK switches is changed to a lower value to ensure sufficient current through the contacts.

1. Turn power OFF to the console and wait until it has cycled down.
2. Unplug the power cord from the power entry module.
3. Remove the LIVE, BLIND, GROUP, and SUB keycaps from the face panel button board.
4. Open the console for service.
5. Unplug all cables and harnesses from the face panel button board.
6. Remove the mounting screws and remove the board from the console.
7. Modify the board on the component side as follows¹:
 - a. Cut pin 2 off of the 4.7K resistor pack (part R316).
 - b. Prepare the resistor pack for installation by soldering a short piece of W106 wire onto the resistor pack pin 1.
 - c. Stand the resistor pack beside U1 with pin 10 of the resistor pack at pin 9 of U1. The pin 1 end of the resistor pack should project past the end of U1.

- d. Solder the pins of the resistor pack to the legs of U1 at pins 2 through 9.
 - e. Solder the short piece of W106 wire from pin 1 of the resistor pack to U1 pin 20.
 - f. Remove the resistor pack RP1 and replace with the 2.2K resistor pack (part R262)².
8. Reinstall the face panel button board.
 9. Reconnect all cables and harnesses which were previously removed.
 10. Reinstall the LIVE, BLIND, GROUP, and SUB keycaps on the face panel button board.
 11. Enter today's date on one of the ECO labels (part I204) and affix it to the PC board.

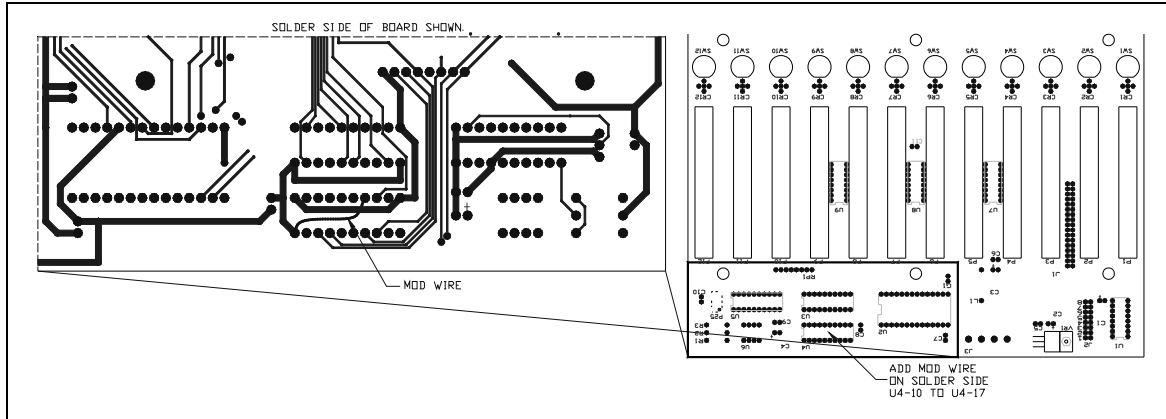
This modification grounds a floating bus buffer input. The face panel FIFO empty flag is read on this port along with the submaster bump buttons. The floating input injects enough noise into adjacent data lines to cause the flag and/or bump buttons to be misread. This procedure is performed on the boards without removing them from the console.

Note: Refer to Figure 2 during the following procedure when modifying 4052B5005 boards. These boards are identified by round bump buttons and one LED above each keycap. The board is shown inverted as it will appear when the console is opened for service.

1. Ensure power is OFF to the console.
2. Connect U4 pin 17 to U4 pin 10 with W106 wire on the solder side of the board³.
3. Perform the previous steps for the second submaster board if one is installed.
4. Enter today's date on one of the ECO labels (part I204) and affix it to the PC board.

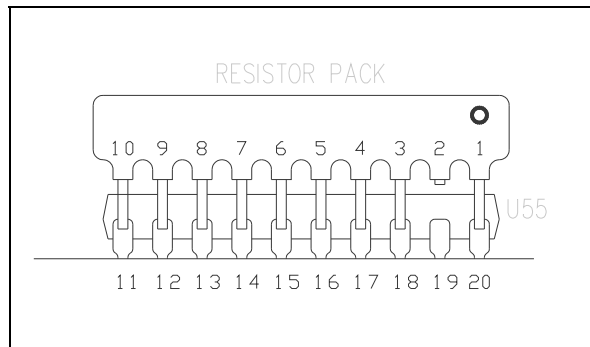
- 2370 *Face panel synchronization errors in remote consoles: added a resistor pull-up to the BD0-7 data lines on the Node board. The resistor pull-up eliminates the bus float between accesses which can inject noise into adjacent data lines.*

11. Install a resistor pull-up pack to U58 as follows⁶:
 - a. Refer to Figure 7 during the following procedure.
 - b. Cut pin 2 off of the 4.7K resistor pack (part R316).
 - c. Stand the resistor pack beside U58 with pin 1 of the resistor pack at pin 20 of U58.
 - d. Solder the pins of the resistor pack to the legs of U58 at pins 11 through 18 and pin 20.
12. Replace the Node board into the chassis and reinstall the mounting screws and standoffs to hold it in place.
13. Replace the external mounting hardware for the Node board connectors.
14. Reconnect all cables and harnesses which were previously removed.
15. Enter today's date on one of the ECO labels (part I204) and affix it to the PC board.

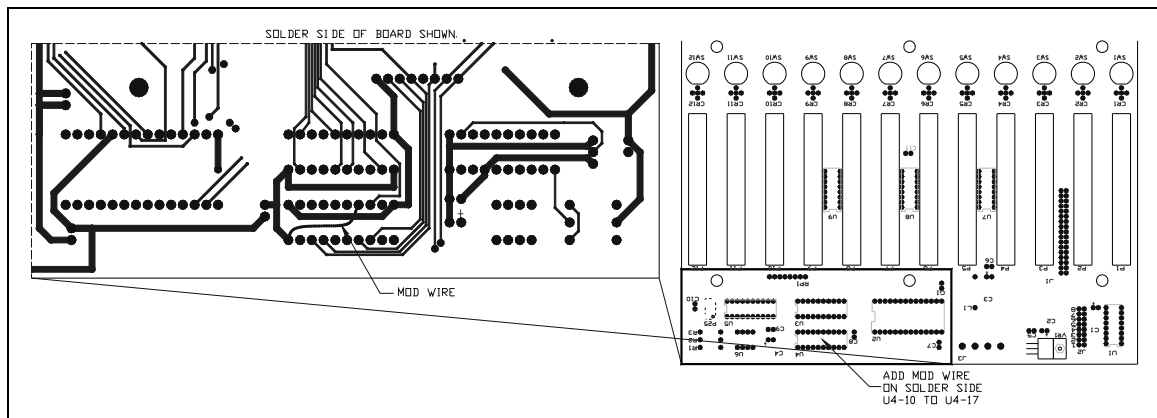
This modification grounds a floating bus buffer input. The face panel FIFO empty flag is read on this port along with the submaster bump buttons. The floating input injects enough noise into adjacent data lines to cause the flag and/or bump buttons to be misread. This procedure is performed on the boards without removing them from the console.

Note: Refer to Figure 10 during the following procedure when modifying 4052B5005 boards. These boards are identified by round bump buttons and one LED above each keycap. The board is shown inverted as it will appear when the console is opened for service.

1. Ensure power is OFF to the console.
2. Connect U4 pin 17 to U4 pin 10 with W106 wire on the solder side of the board⁹.
3. Perform the previous steps for the second submaster board if one is installed.
4. Enter today's date on one of the ECO labels (part I204) and affix it to the PC board.
