Electronic Theatre Controls, Inc.
3030 Laura Lane
Middleton, WI 53562

Manual 4052M1019 Obsession Upgrade Installation Instructions

Obsession Full Console Upgrade Kit (4052S1018)

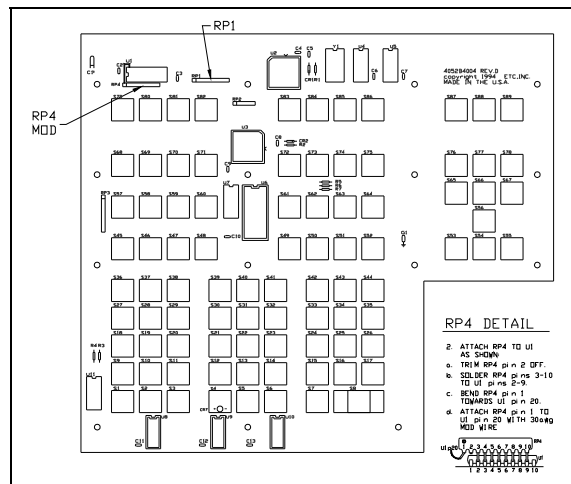
This modification adds resistor pull-ups to the BD data lines and changes another pull-up package to increase the current through the GO and STOP/BACK switches. When the FIFO empty flag is read through the local port, only bit zero is active and the rest of the bits float. This injects noise into the active bit and can cause it to be misread. The resistor pull-up for the GO and STOP/BACK switches is changed to a lower value to assure sufficient current through the contacts.

Note: Refer to Figure 9 during the following procedure.

- f. Remove the resistor pack RP1 and replace with the 2.2K resistor pack (part R262)⁸.
8. Reinstall the face panel button board.
9. Reconnect all cables and harnesses which were previously removed.

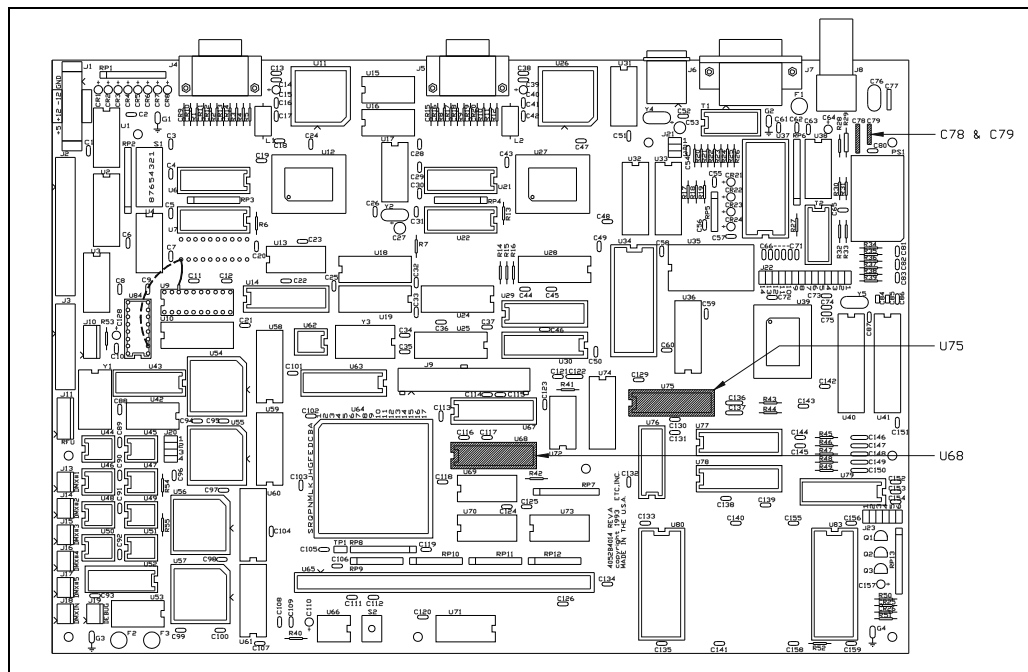
Note: This modification changes PALs on the Node board and makes other changes which increase the reliability of the board. Refer to Figure 17 during the following procedure.
